Anterior Full Ceramic Crown after a Complicated Fracture of the Natural Tooth

This clinical report illustrates the restoration of a maxillary central incisor affected by a complicated crown fracture with a veneered lithium-disilicate glass ceramic crown after endodontic therapy.

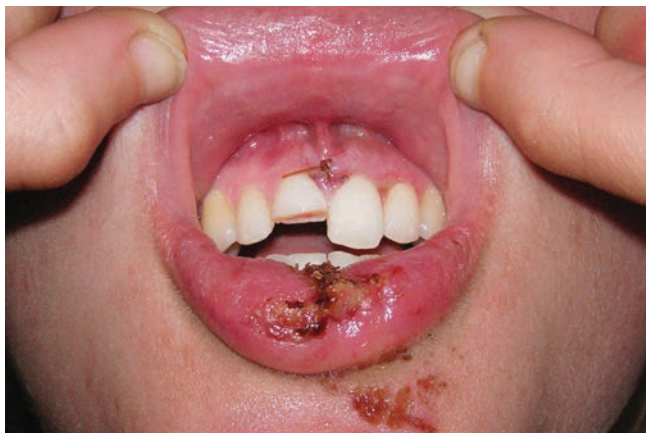
Fig. 1 — Initial situation: 24-year old female patient after trauma. In addition to the fractured tooth 11, there is extensive injury to the lower lip. The first treatment of the soft tissue injury occurred at the venue of the accident abroad.

occurred in a developing country with medical and dental treatment localities not corresponding to modern standards, the patient decided - after the initial treatment of soft tissue injuries on the spot by a fellow student (Fig. 1) - to cancel the stay abroad for the dental therapy, because she preferred a treatment in the familiar environment according to modern standards.

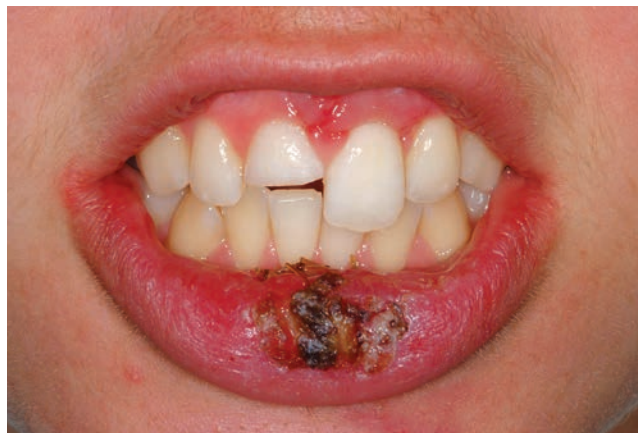
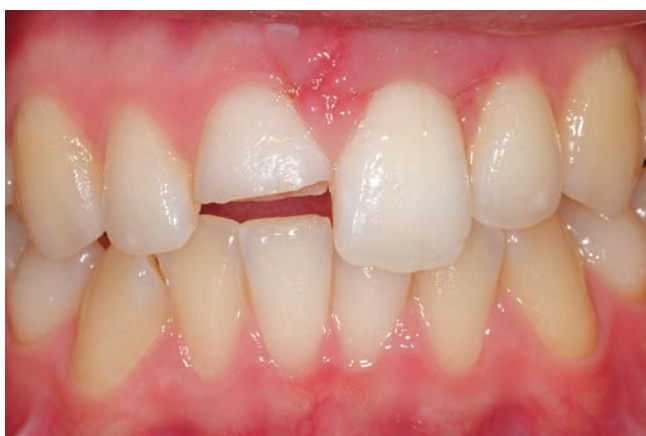
Fig. 2a — One week later, the patient appeared in our dental office. Tooth 11 had a complicated crown fracture with exposure of the pulp.

Fig. 2b — The incisal half of the clinical crown of tooth 11 had fractured horizontally.

During the examination in our clinic one week after the incident, the patient presented a still untreated trauma-injured tooth 11 (Fig. 2 a and b). The clinical inspection showed a complicated crown fracture with exposure of the pulp (Fig. 3), the incisal half of the clinical crown had been completely lost [62, 63]. Patient assessment revealed a sharp painful response to cold thermal stimulus using refrigerant spray and a pathologic response to percussion of the respective tooth [64]. The pulp had already been exposed to the oral cavity environment for one week, the tooth showed unprovoked pain symptoms and root growth was complete; thus, we decided together with the informed patient, to completely remove the infected pulp with subsequent root canal treatment (Fig. 4 a to c).

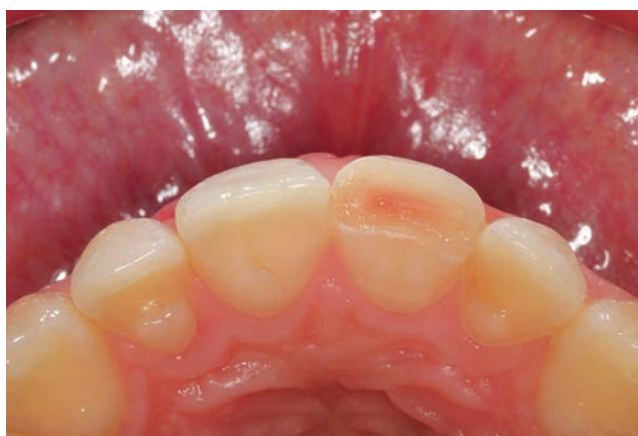
Fig. 3 — Exposure of the pulp was diagnosed at the mesial aspect of the fracture site.

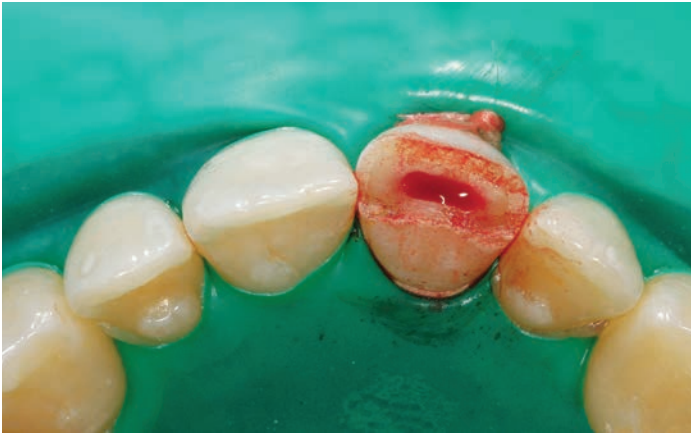
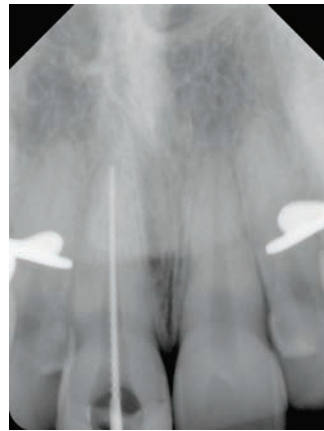
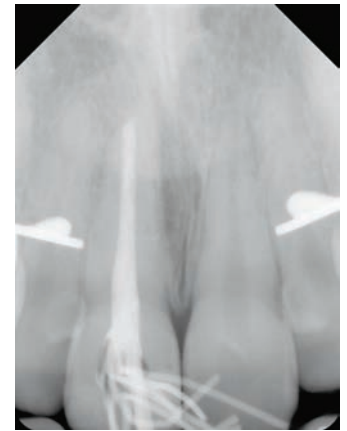
Fig. 4a — Root canal treatment was initiated, since the pulp had already been exposed to the oral cavity environment for one week.

Fig. 4b — Periapical radiograph to determine the working length.

Fig. 4c — Control radiograph of the root canal filling in lateral condensation technique.

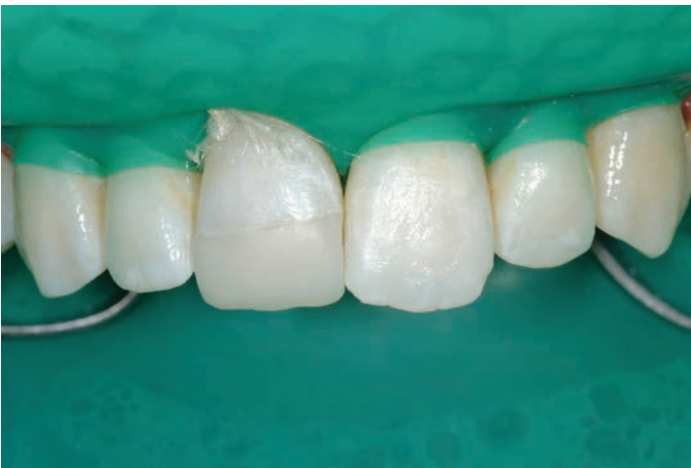
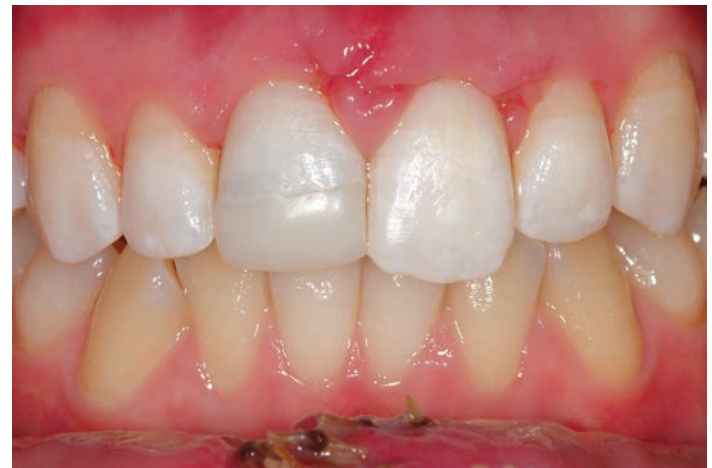
Fig. 5a — Long-term provisional build-up of the tooth with a direct composite restoration.

Fig. 5b — The composite restoration remained until completed soft tissue healing.

After completion of the root canal treatment, a long-term provisional build-up of the tooth was carried out with an adhesive direct composite restoration (Fig. 5 a and b) in order to spare the patient a preparation and impressions until the soft tissue situation had completely healed. After a waiting period of 3 months, a new clinical examination was carried out, in which the tooth 11 and its adjacent teeth, including the antagonists in the lower jaw, were inconspicuous (Fig. 6). The patient was asked to present herself the next day for shade determination and in general for dental aesthetic analysis in the dental laboratory [66]. A basic requirement for accurate color determination is that the teeth are not dehydrated, otherwise they appear lighter and more opaque [67-69]. As part of the aesthetic analysis by the dental technician, the distribution of the different shades of color and translucent or opaque tooth areas in the area to be restored is determined (Fig. 7a to d). The age-appropriate design of the restoration with corresponding

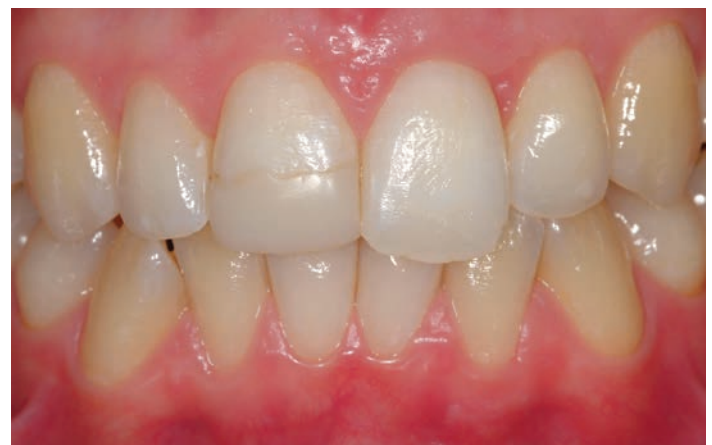
Fig. 6 — After 3 months, the soft tissue situation presented in perfect condition.

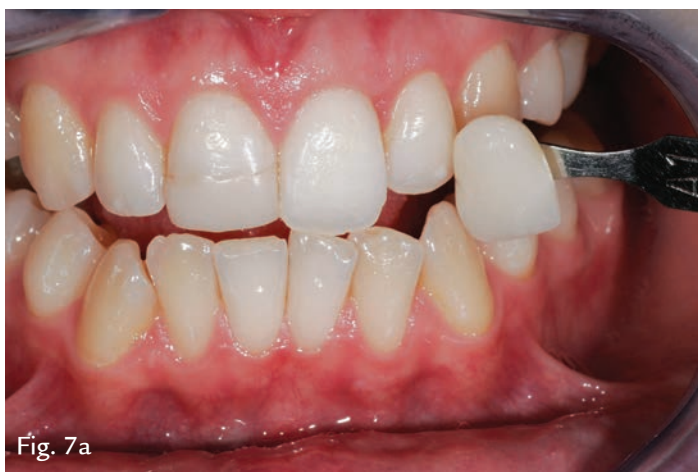
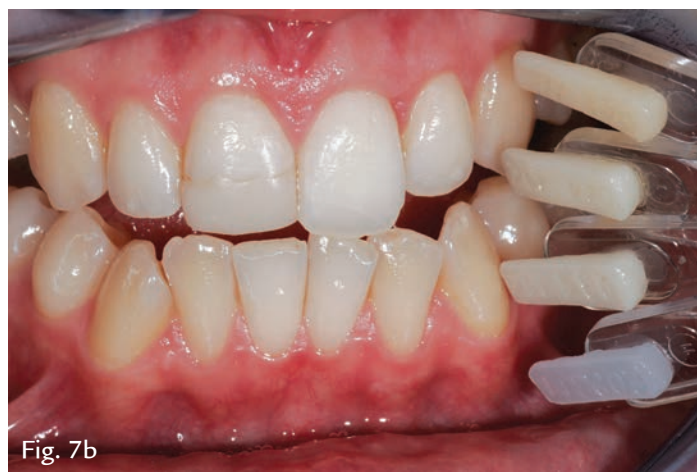
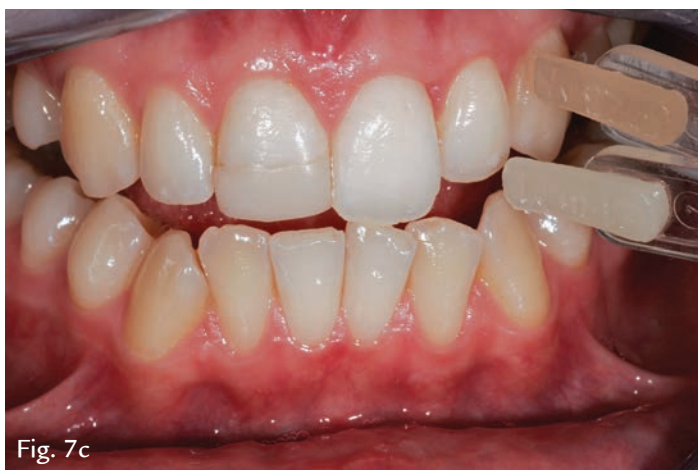
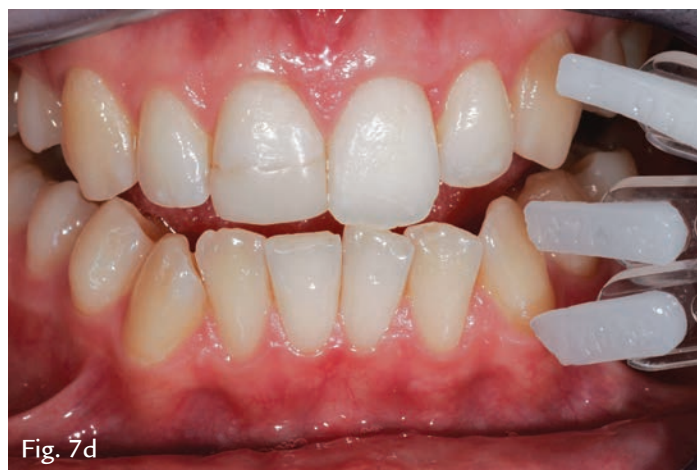
Figs. 7a to d – Aesthetic analysis by the dental technician. The distribution of the different shades and translucent or opaque tooth areas in the area to be restored are determined.

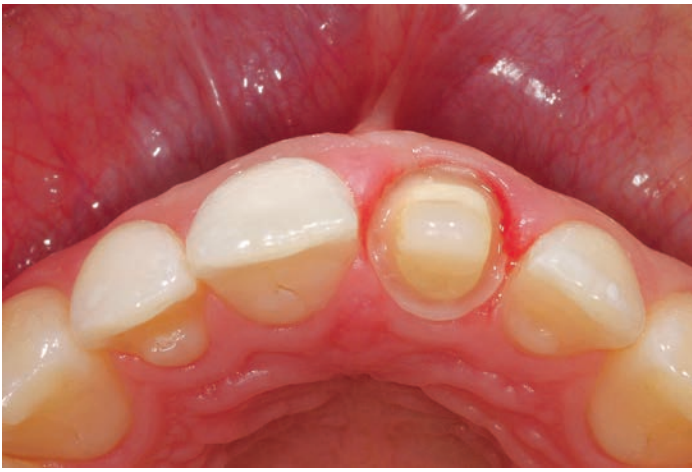
Fig. 9c — Incisal view of the final preparation with a circumferential shoulder of 1 mm depth.

In the next appointment, the tooth 11 was prepared for receiving a full ceramic crown with a circumferential shoulder with rounded inner edges (Fig. 9 a to c).

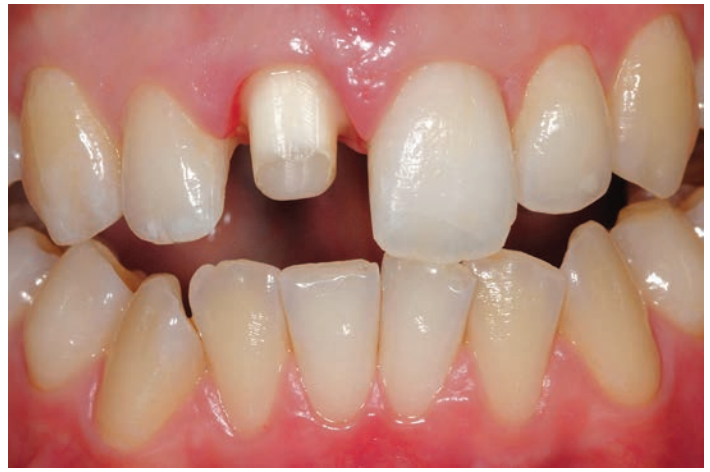
Fig. 10 — Tooth substance removal was controlled in dynamic occlusion to ensure sufficient thickness of the glass ceramic framework.

Tooth substance removal was controlled in all dimensions. Attention was paid to the possibility of a sufficient palatal layer thickness of the crown framework to be produced, even in positions which the tooth occupies - in addition to the static occlusion - in dynamic occlusion (Fig. 10).

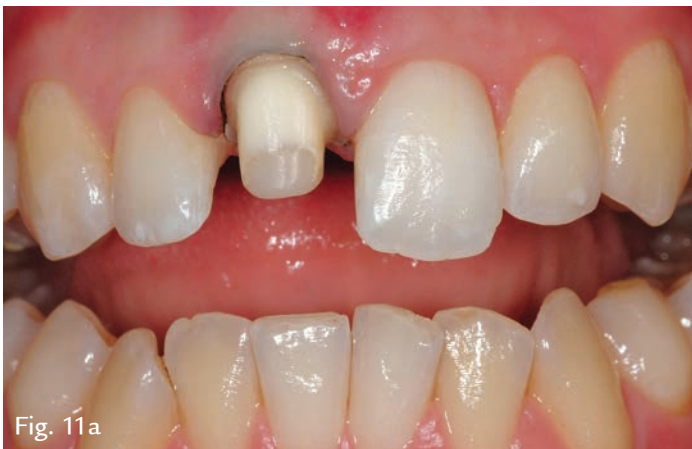
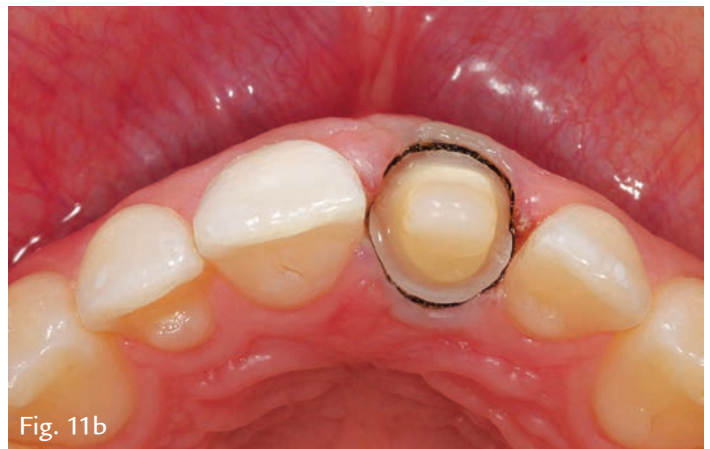
Figs. 11a and b — Placing a retraction cord to displace the marginal gingiva and expose the finish line before taking an impression.

In order to achieve a perfect impression, the marginal gingiva was displaced by insertion of a retraction cord to the sulcus (Fig. 11 a and b). After taking impressions of the prepared tooth and the antagonistic dentition, an

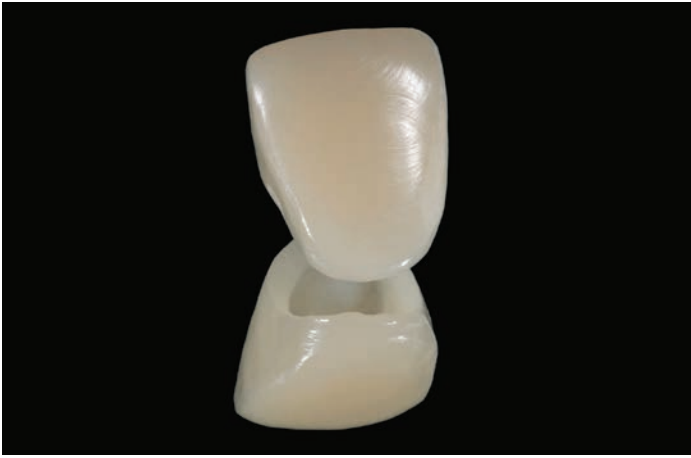
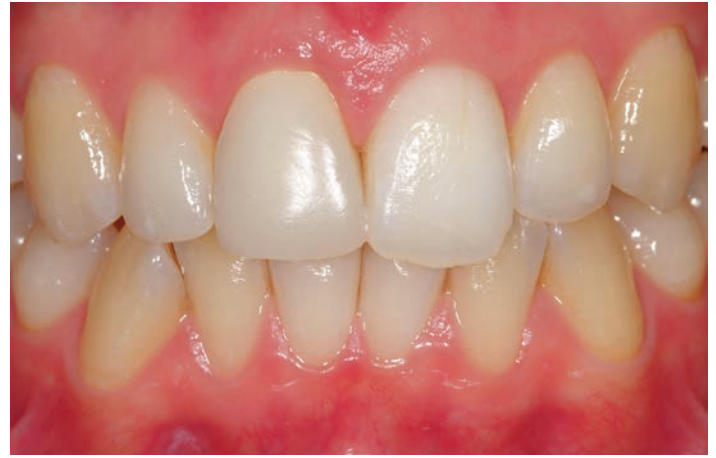
Fig. 12a — Chairside fabrication of a direct provisional restoration.

Fig. 12b — The provisional was seated using an eugenol-free temporary cement.

A diagnostic template made from a gypsum duplicate of the analytical wax-up using a transparent polyethylene foil allows the chairside fabrication of a direct provisional restoration with correct dimensions and alignment (Fig. 12 a). The provisional was seated using an eugenol-free temporary cement (Fig. 12 b).

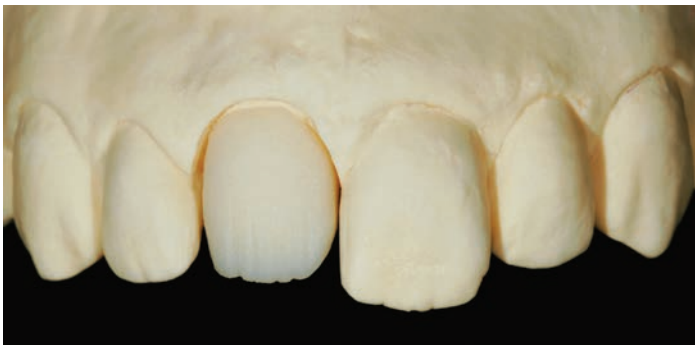
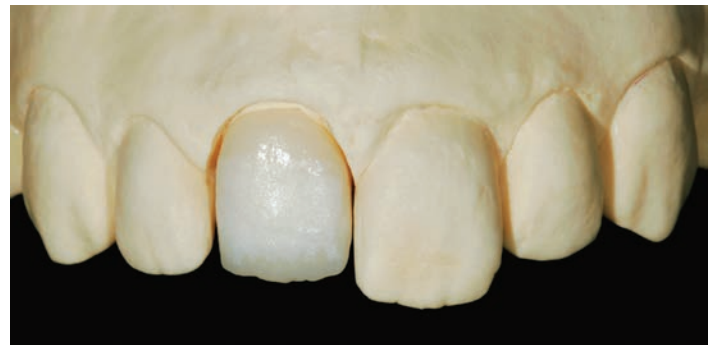
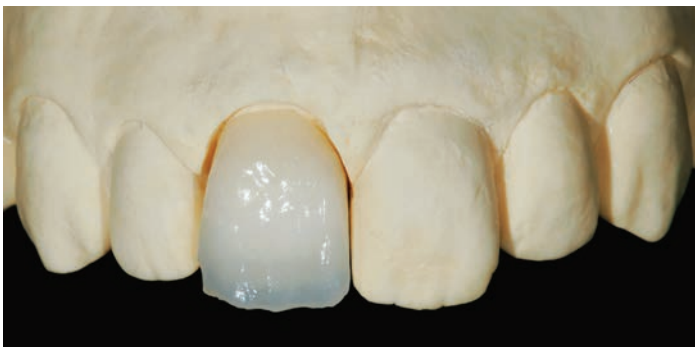
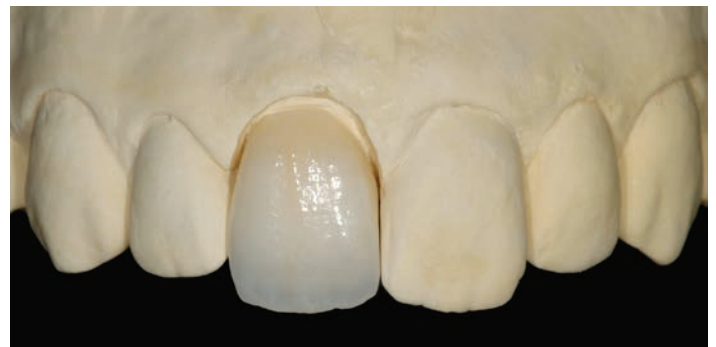
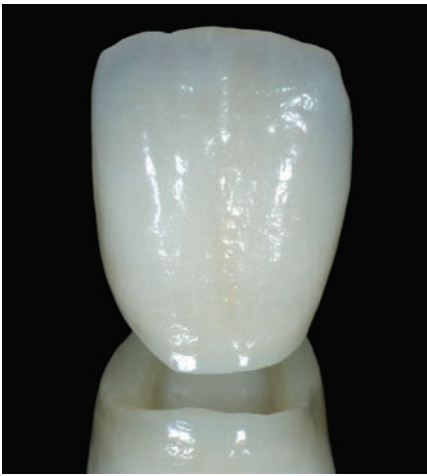
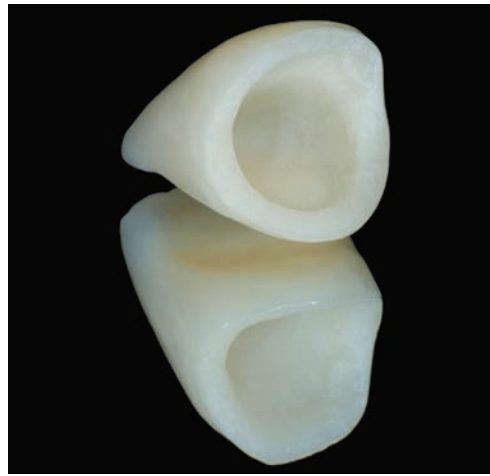
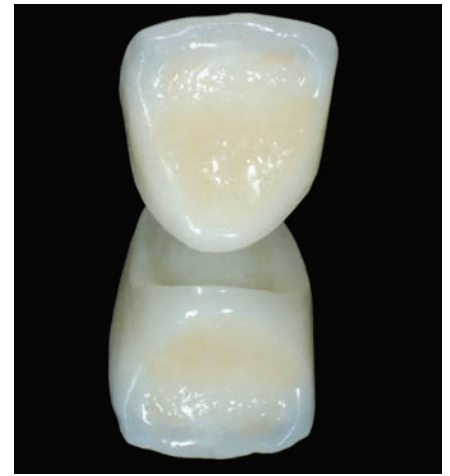
Fig. 13a — Pressed crown framework made of lithium-disilicate-reinforced high-strength glass ceramic.

Fig. 13b — First bake of the veneering porcelain.

Fig. 13c — Second bake of the veneering porcelain.

Fig. 13d — Finalized full ceramic crown made of a pressed lithium-disilicate coping and individually layered veneering porcelain.

Fig. 13e — The ceramic crown exhibits a natural-looking, life-like surface texture.

Fig. 13f — The circular 1-mm shoulder is clearly detectable.

Fig. 13g — Palatal surface of the ceramic crown.

In the dental laboratory, the ceramic crown for tooth 11 was produced. For this purpose, a crown framework made of lithium-disilicate-reinforced high-strength glass ceramic was pressed corresponding to the anatomically correct shape of the respective tooth (Fig. 13 a). This coping was subsequently finalized by individual veneering with layered porcelain (press-layer-technique) (Fig. 13 b to g).

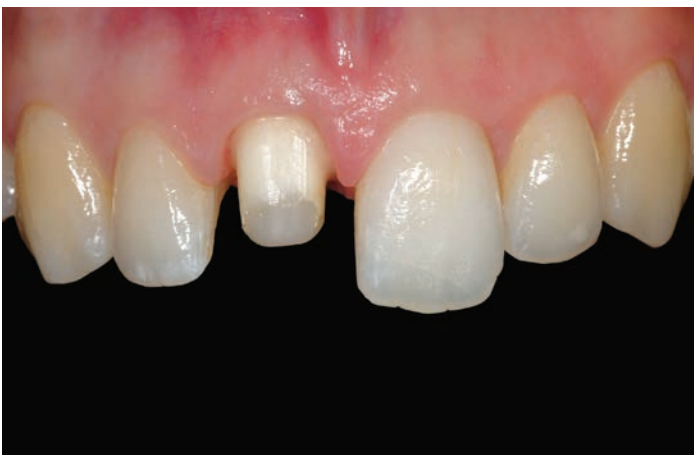
Fig. 14 — Situation after removal of the provisional restoration. The marginal gingiva presents in perfect condition.

was scheduled. After removal of the provisional restoration and cleaning of the tooth with a rotating brush and fluoride-free prophylaxis paste, the gingiva presented in healthy condition (Fig. 14). Using colored, glycerin-based, try-in pastes, the aesthetics of the ceramic crown was checked intraorally with reference to hydrated adjacent teeth and the correct shade of the luting resin was determined [83-85]. Subsequently, the precise fit of the crown on the prepared tooth and quality of proximal contacts were checked

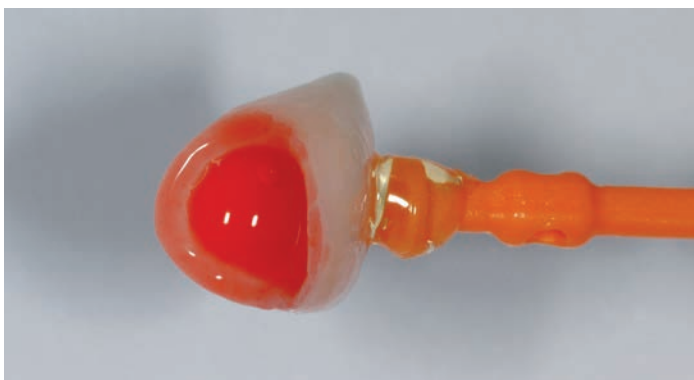
Fig. 16 — Etching the inner surface of the lithium-disilicate glass ceramic crown with hydrofluoric acid for 20 s.

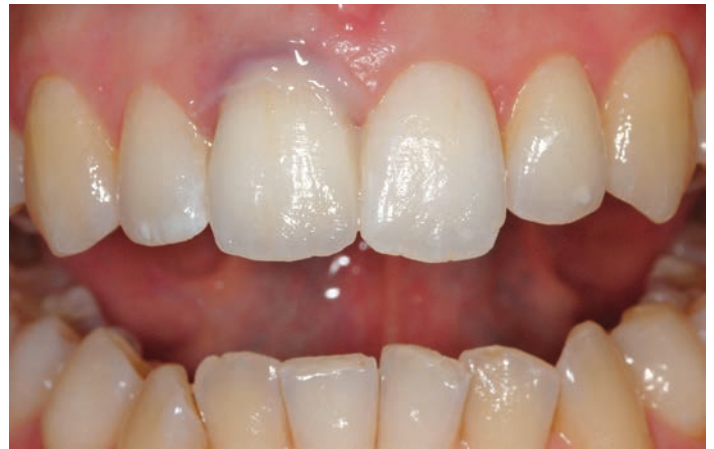
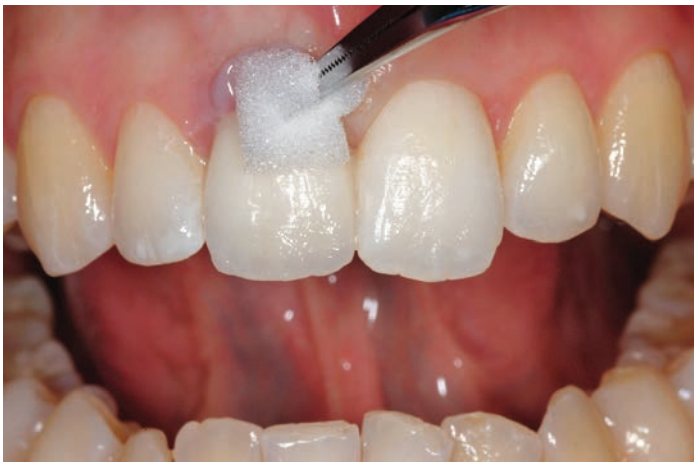
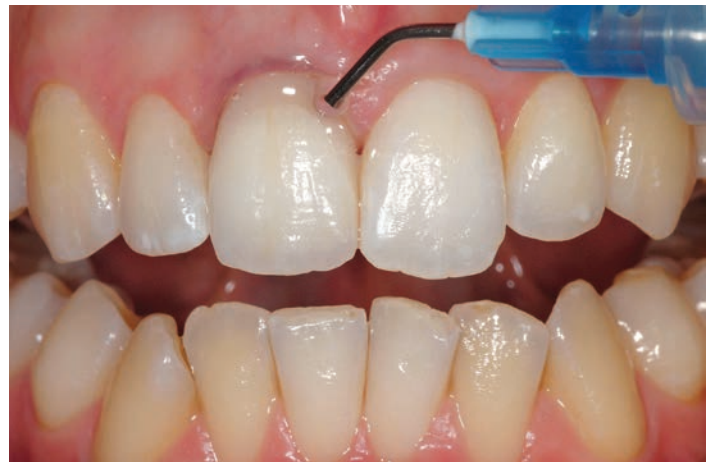
Fig. 20a – The ceramic crown is positioned on the tooth with a dual-curing luting composite.

Fig. 20b – The excess resin cement is carefully removed using a foam pellet.

Fig. 20c – Placing a glycerin gel on the luting gap to avoid the formation of an oxygen-inhibited superficial composite layer.

Fig. 20d — Light polymerization of the dual-cure resin cement.

The adhesive cementation of ceramic restorations is a very technique-sensitive procedure. In order to achieve a reliable and long-lasting bond to the tooth structures, it is of utmost importance to prepare this step carefully and to observe the cementation protocol^[87]. Prior to the luting procedure, the marginal gingiva was displaced to expose the complete shoulder using a retraction cord (Fig. 15). Afterwards, the inner surfaces of the lithium-disilicate glass ceramic crown were etched with hydrofluoric acid for 20s (Fig. 16). After thoroughly rinsing and drying the crown, the fitting surfaces were silanized (Fig. 17)^[88-91]. After adhesive pretreatment of the prepared tooth by conditioning enamel and dentin with 37% phosphoric acid (Fig. 18) the tooth was thoroughly rinsed with water-spray and air-dried. An adhesive was applied meticulously on all surfaces (Fig. 19 a). After the correct exposure time the bonding layer was air-thinned and the solvent was evaporated carefully with compressed air (Fig. 19 b). The ceramic crown was adhesively luted by covering its intaglio surfaces and the prepared tooth both with dual-curing resin cement in the previously determined shade and the restoration was positioned on the tooth with light finger pressure (Fig. 20 a to d).

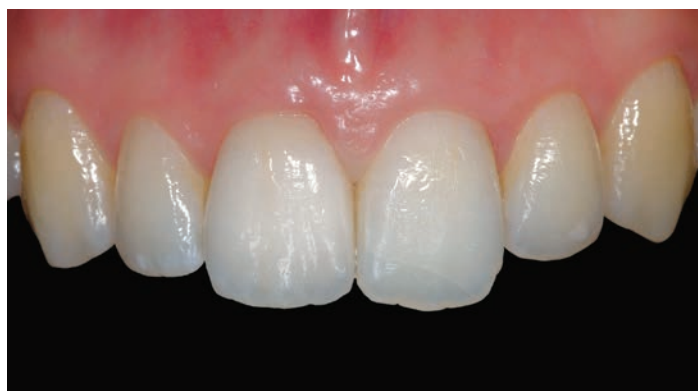
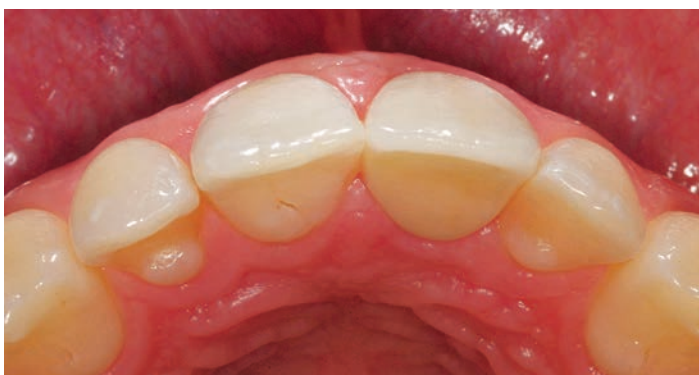
Fig. 21a — The ceramic restoration exhibits a perfect functional and aesthetic integration into the neighboring teeth.

Fig. 21b — The incisal view shows a copy of the natural central incisor.

Two weeks after placement, the restoration exhibited an optimal functional and aesthetic integration into the neighboring teeth (Fig. 21 a and b). Background illumination demonstrates the excellent light transmittance capacity of the glass ceramic crown, which impresses by having virtually the same optical properties as the surrounding natural dentition (Fig. 22). Ultraviolet light activates the inherent fluorescence properties of the restoration, which are equal to natural tooth structure (Fig. 23). Silicate ceramics exhibit translucency effects and light-optical properties that are comparable to natural hard tooth substance, making them ideal for fabricating restorations that have to meet highest aesthetic demands. The light scattering of silicate ceramics also supports a natural vital appearance of the adjacent gingiva. The difference to this "pink aesthetics" becomes clear in comparison with metal-supported restorations, which block this light conduction towards the marginal soft tissue and often cause a grayish shading on the marginal gingiva^[92, 93]. At the end of the successful treatment, the patient's smile was no longer compromised (Fig. 24).

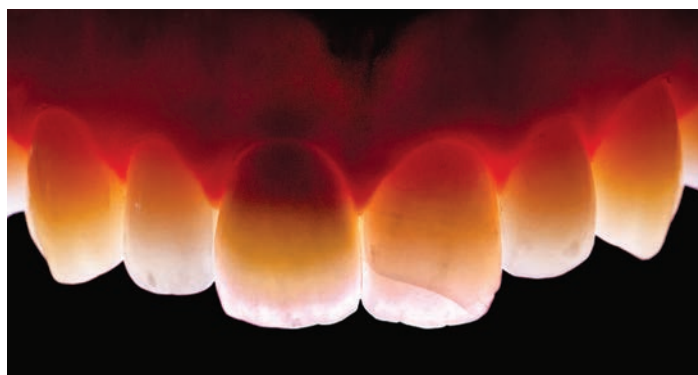
Fig. 22 — Excellent light transmittance capacity of the ceramic crown, indistinguishable from the neighboring dentition.

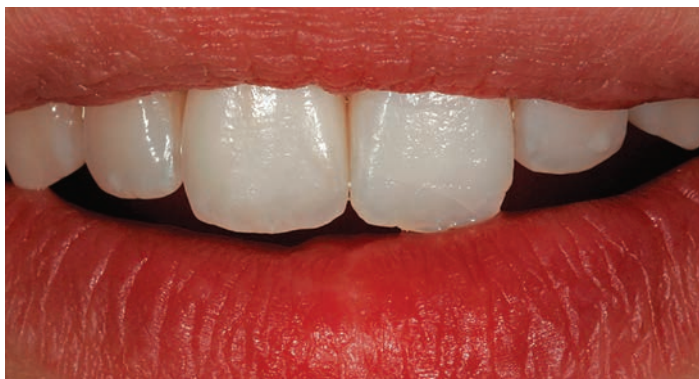
Fig. 24 — The ceramic crown shows a perfect harmony with the architecture of the lips.

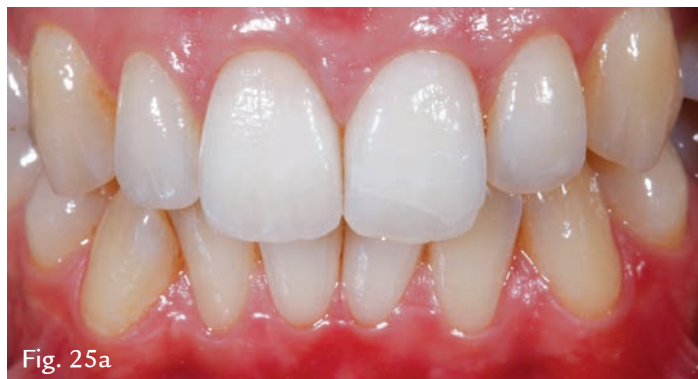
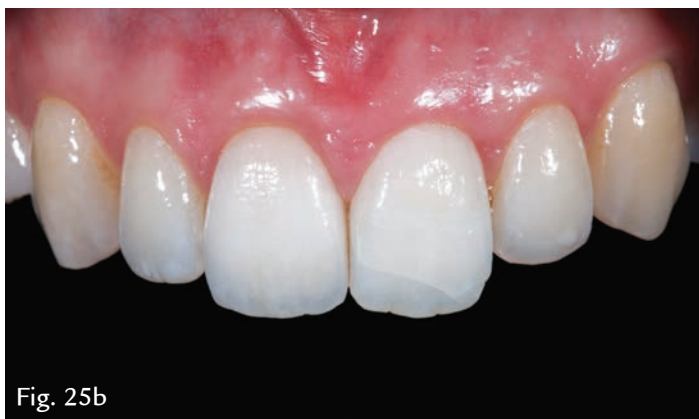
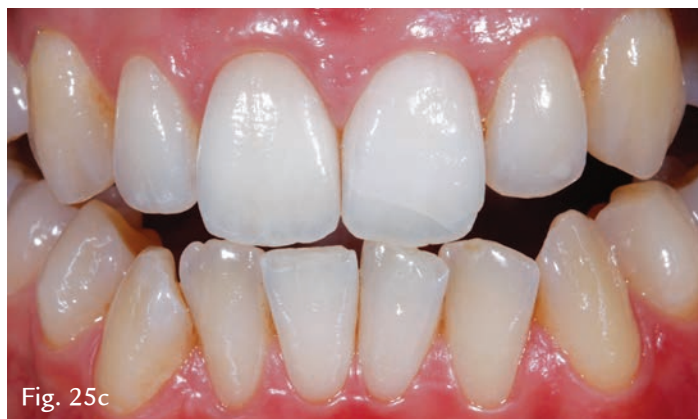
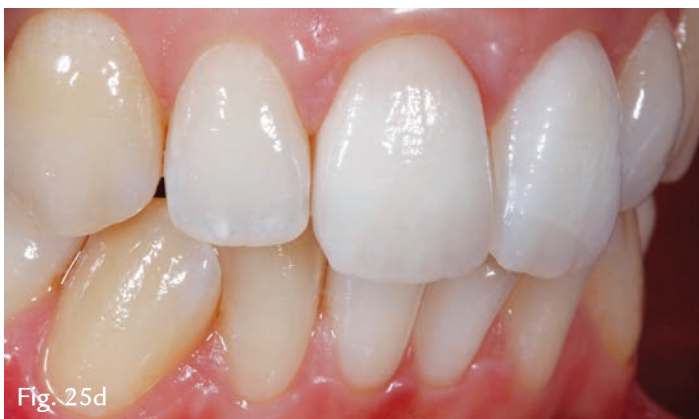
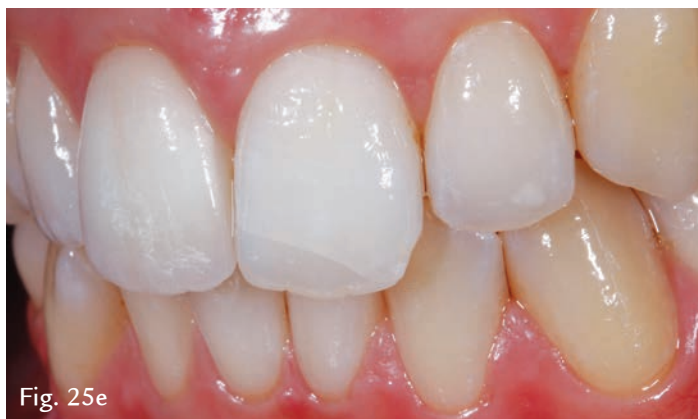
Figs. 25a - c — Five years after incorporation, there is still an excellent integration of the crown into neighboring dentition.

Figs. 25d - e — In the right and left lateral views, the crown also presents inconspicuously.

Five years after adhesive cementation of the ceramic crown, there is still an excellent integration in the surrounding teeth, both in habitual intercuspation and in dynamics (Fig. 25 a to e). The crown still harmonizes in dialogue with the lips. Finally, the patient thanks the treatment team with a happy smile (Fig. 26).

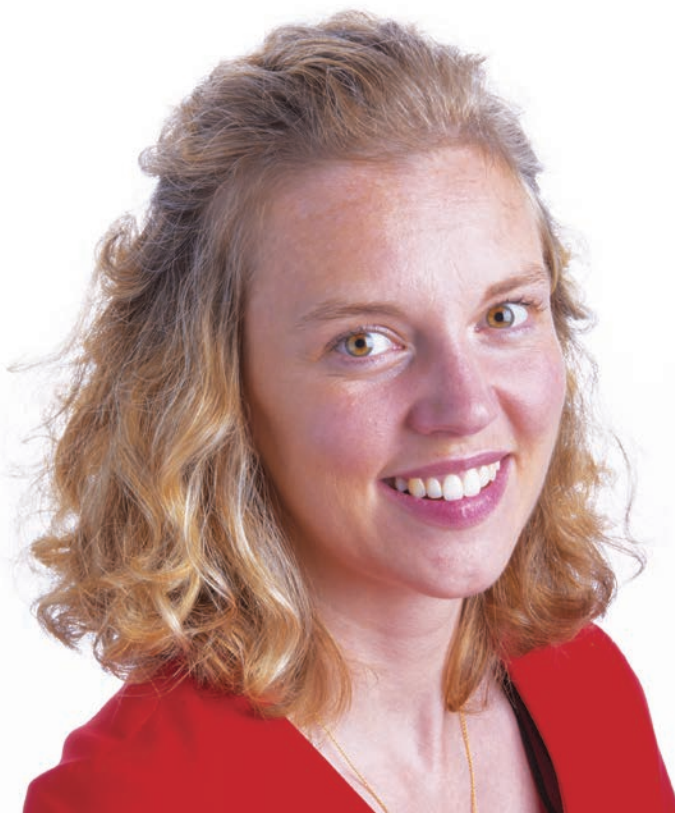
Fig. 26 — The patient was fully satisfied with the result and presented a warm and big smile to the dental team as a reward for the completed treatment.
